BAM CITADEL, YESTERDAY AND TODAY -PREVENTION FACTORS OF BRICK MONUMENTS DESTRUCTION

SHAHBAZI H.

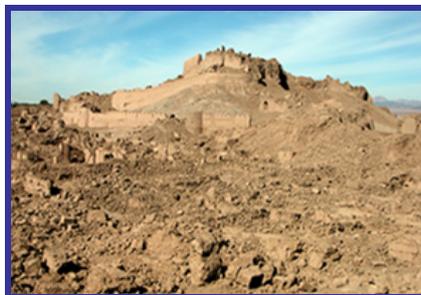
Figure: Bam citadel after earthquake

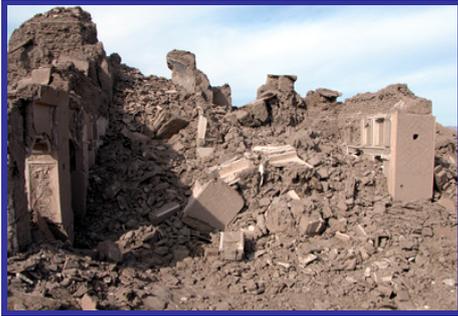
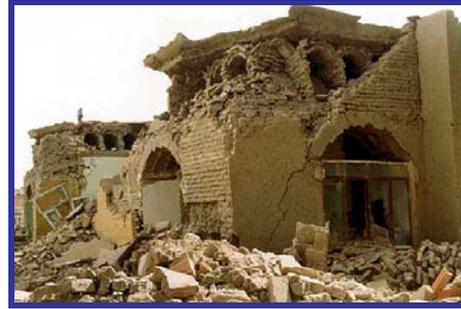
Figure: Lack of observance in repair and strengthening

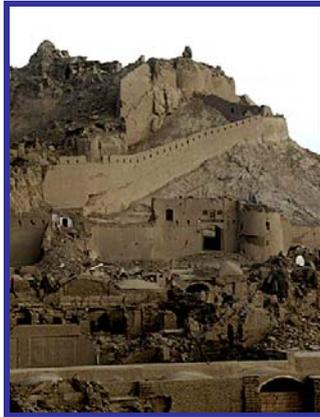
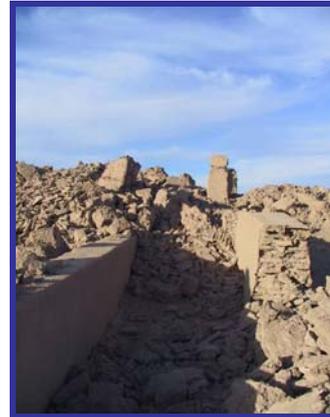
Figure: Pictures of citadek bam after earthquake
